ANALYSIS OF STRESS CORROSION CRACKING OF HETEROGENEOUS WELDED JOINTS IN SIMULATED PRIMARY WATER ENVIRONMENT

Original scientific paper

The paper deals with the stress corrosion cracking of heterogeneous welded joints. The welded joints were made of austenitic base metal (AISI 321) and ferritic weld metal by arc welding. Two methods were used to analyze the stress corrosion cracking of samples of this type of welded joint. The first method was a slow strain rate test (SSRT) using a tabletop device at a temperature of 60°C with a graded strain rate for three specimens (10^{-5} , 10^{-6} , and 10^{-7} 1/s). The second method was exposure in a corrosion autoclave at a temperature of 270°C and pressure of 12.26 N/mm², while prestressing devices were used to achieve the prestressing at the level of yield strength and 3% plastic deformation. One specimen was bent to 60°. Boric acid solutions were used as the medium, which was supposed to simulate the environment of the primary circuit of nuclear power plants, a type of water-water energetic reactor. The surface and the presence of corrosion products, cracks, fractures, or pits on specimens were monitored using scanning electron microscop

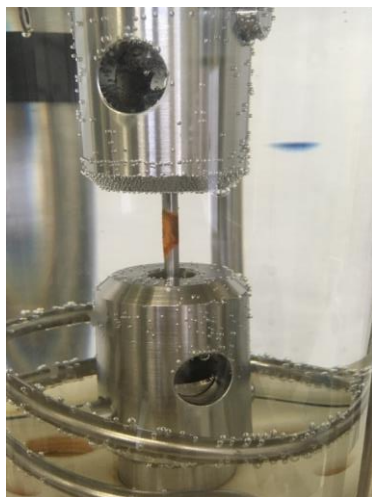
During the SSRT test, the tensile specimens ($L_0 = 25.4$ mm and circular cross-section $S_0 = 12.56$ mm²) were fixed in the holders of the blasting device (Fig. 1). One specimen was tested during one test – three specimens were used for individual deformation rates. An H_3BO_3 solution with a concentration of 13 g/dm³ was added to the chamber and heated to a temperature of 60°C. After this operation, the SSRT program was started on the PC, where the deformation rates (A:10⁻⁵, B:10⁻⁶, and C:10⁻⁷ 1/s) were set.

Fig. 1. Specimen pulled during SSRT

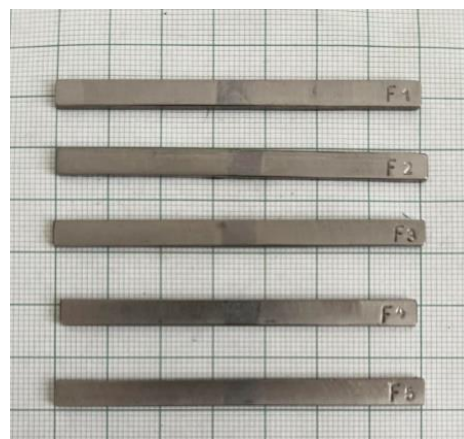
prestressed at the weld metal-base metal (WM-BM) interface by means of screws and ceramic balls by the 3-point bending to the yield strength or 3 % plastic deformation, respectively (based on NACE standard TM0177-2016, method B – Fig. 3). Values of R_e and $\sigma_{3\%}$ were calculated for AISI 321 in 270°C. One specimen was bent at the WM-BM interface to 60°. Subsequently, the specimens were placed in an autoclave, and the test was started while the exposure time was 60 days.

Fig. 2. Specimens for exposition in autoclave

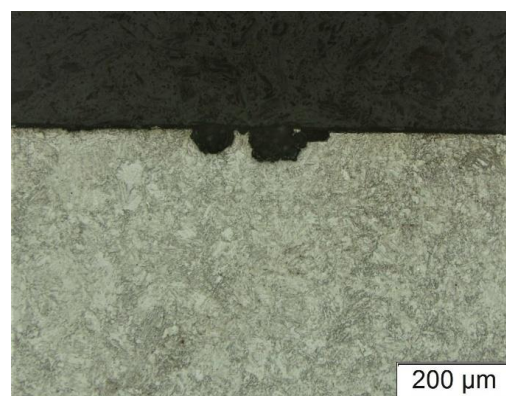
Fig. 6. Pitting on the surface of ferritic weld metal of specimen A (10^{-5} 1/s) obtained by light microscope

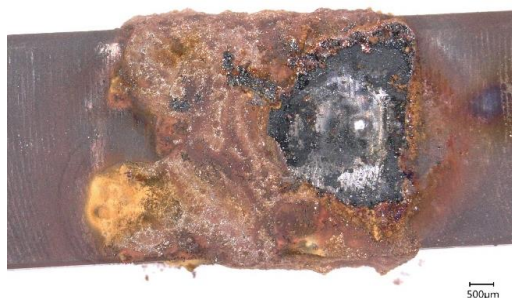
The specimens, which were prestressed and exposed in the prepared environment of the H_3BO_3 + KOH solution, were selected after 60 days and observed using a stereomicroscope. The corrosion products of the weld metal were observed (Fig. 8). After the ultrasonic cleaning, the presence of cracks was monitored - but in no case was the presence of cracks confirmed. Specimens were weighed, and the corrosion rates were calculated. Pits were discovered under the corrosion layer in some specimens (F2, F3, and F4), while in specimen F2, which was prestressed to the yield strength, the pits had a maximum depth of 70.6 μm , and in specimens F3 and F4 (prestressed to 3 % plastic deformation), the pits had a maximum depth of 171.2 and 158.1 μm , respectively. Confocal microscopy was used to analyse the depth of the pits (Fig. 9).

**Fig. 8.** Weld joint of F4 specimen after exposure in autoclave test
